David Golieri
Machinery Health Analyst, Remote Analysis

Emerson Process Management
Asset Optimization Division
835 Innovation Drive
Knoxville, TN 37932

8 May, 2007

Vibration data was collected at your facility 30 April – 3 May 2007. Analysis was performed on that data 7 – 8 May 2007. The attached report is intended to inform you of any significant machinery problems identified during this analysis.

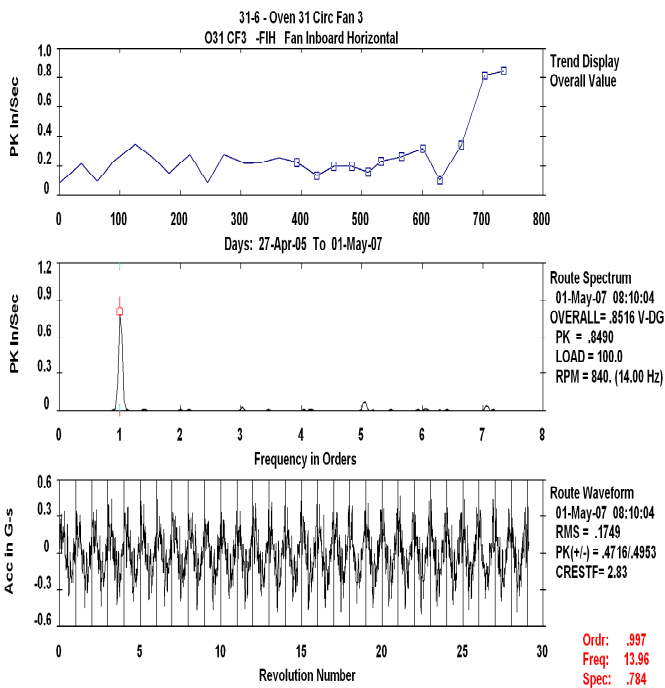
The 1x turn speed vibration on the fan inboard horizontal point has increased since last data. The imbalance in the fan is getting worse. That is the reason for the increased severity. The fan vibration is also increasing on the motor points indicating the imbalance is being coupled to the motor.

Recommend inspecting the fan for buildup on blades and balancing the fan if removing buildup does not resolve the problem.

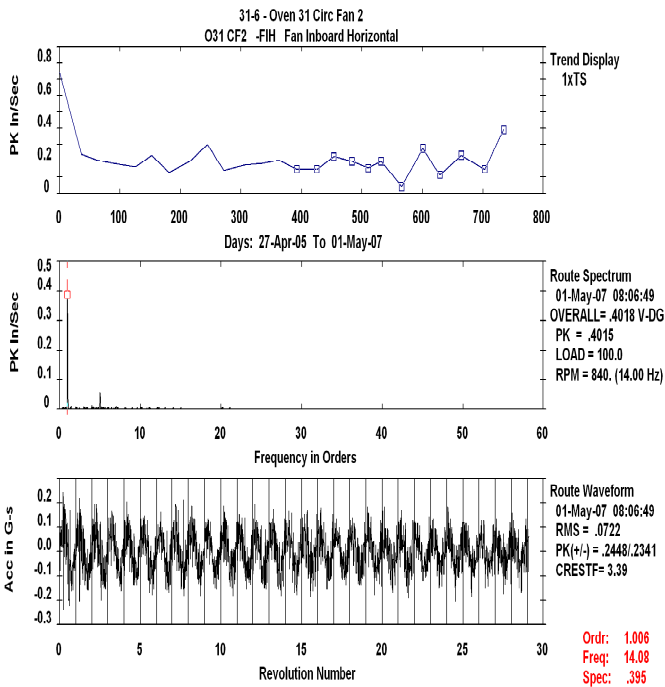
Area 31-6 **Oven 31 & Mill 6**
Equipment O31 CF2 Oven 31 Circ Fan 2

Explanation: The fan inboard horizontal point has an increasing 1x fan speed vibration indicating imbalance in the fan. This is also seen on the motor axial point.

Recommend inspecting the fan blades for buildup and fan for imbalance.

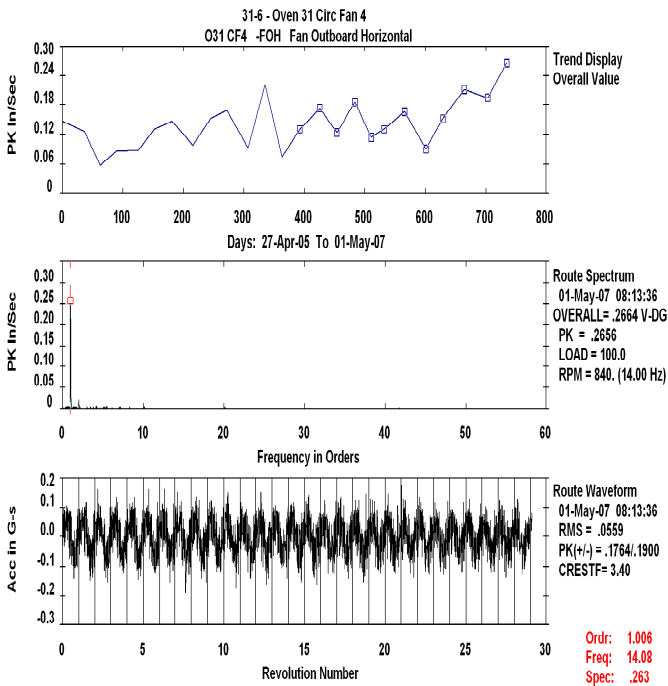
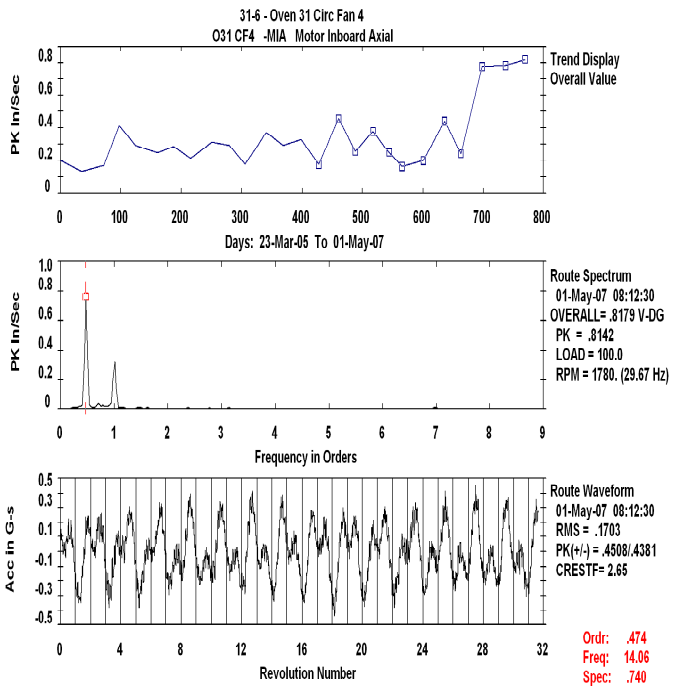
Area 31-6 **Oven 31 & Mill 6**
Equipment O31 CF4 Oven 31 Circ Fan 4

The motor points have 1x fan speed vibration indicating a misalignment of the pulley/sheaves. The fan 1x vibration is also increasing indicating some imbalance in the fan.

Recommend inspecting the pulley/sheaves for proper alignment and belt tension. Also check the fan blades for buildup.

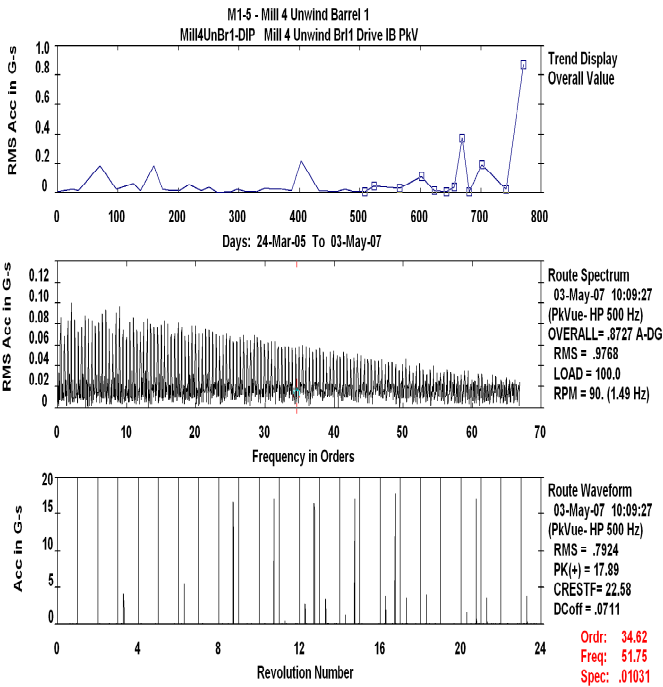
Area M1-5 Mills 1, 2, 3, 4 & 5
Equipment Mill4UnBr1 Mill 4 Unwind Barrel 1

Explanation: The barrel drive inboard PeakVue point has a significant increase in impacting and 1x turn speed harmonics. No other points have high vibration. Suspect bad data on this point.

Recommend retaking data on this point for analysis.

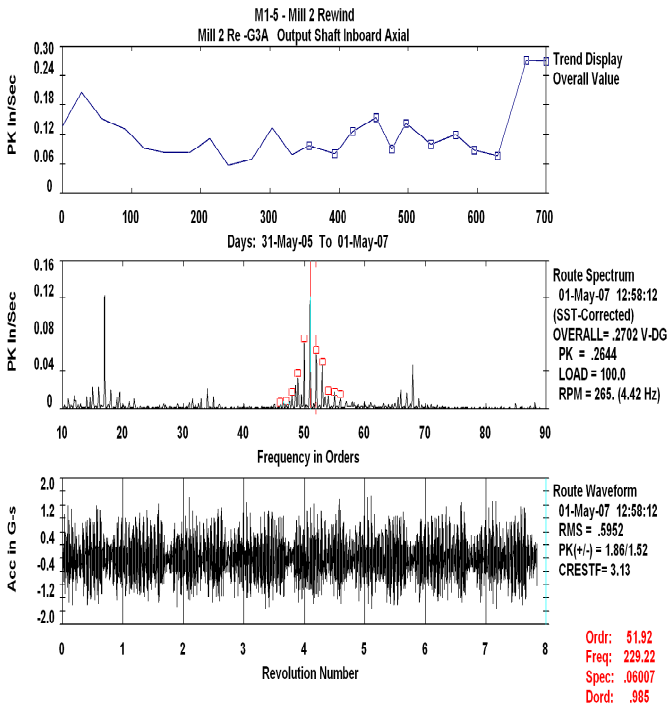
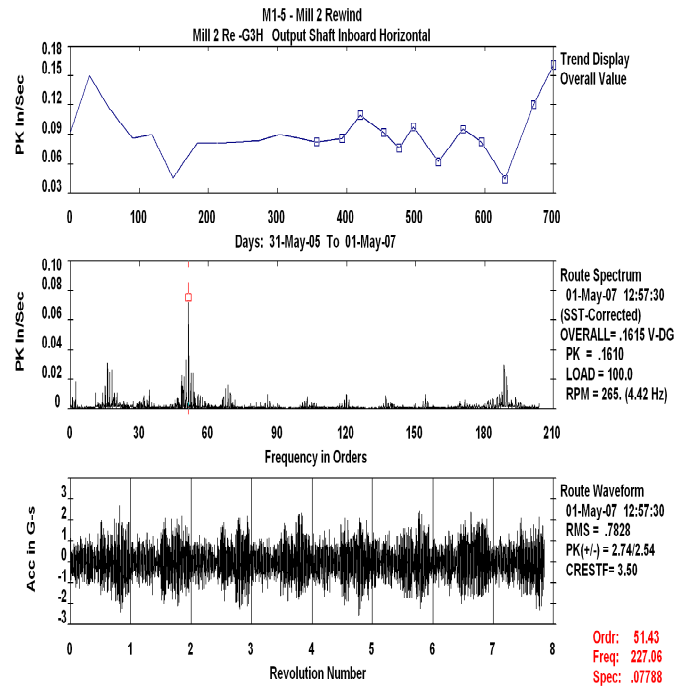
Area M1-5 Mills 1, 2, 3, 4 & 5
Equipment Mill 2 Re Mill 2 Rewind

The gearbox has vibration peaks with sidebands at 1x turn speed. This indicates a bearing defect if speeds are correct. If speeds are incorrect it could be a gear defect.

Recommend taking an oil sample on the gearbox to help determine the source and severity of the defect.

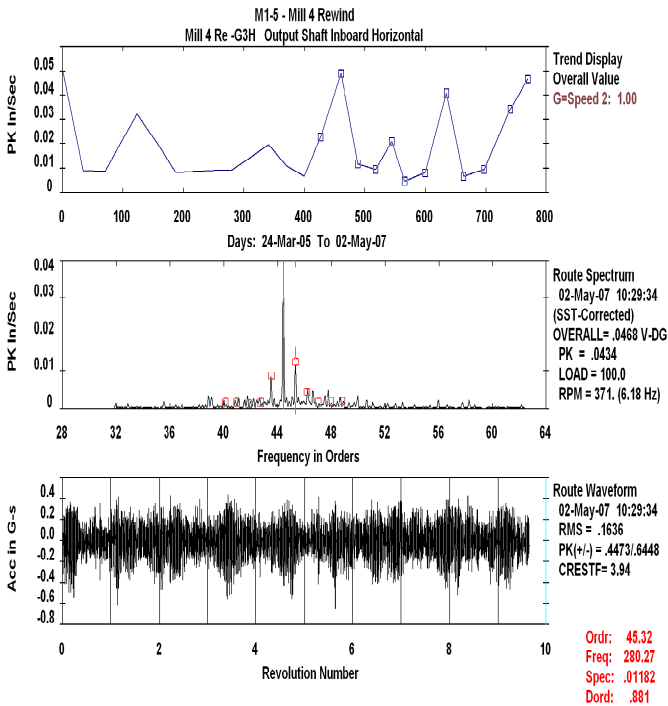
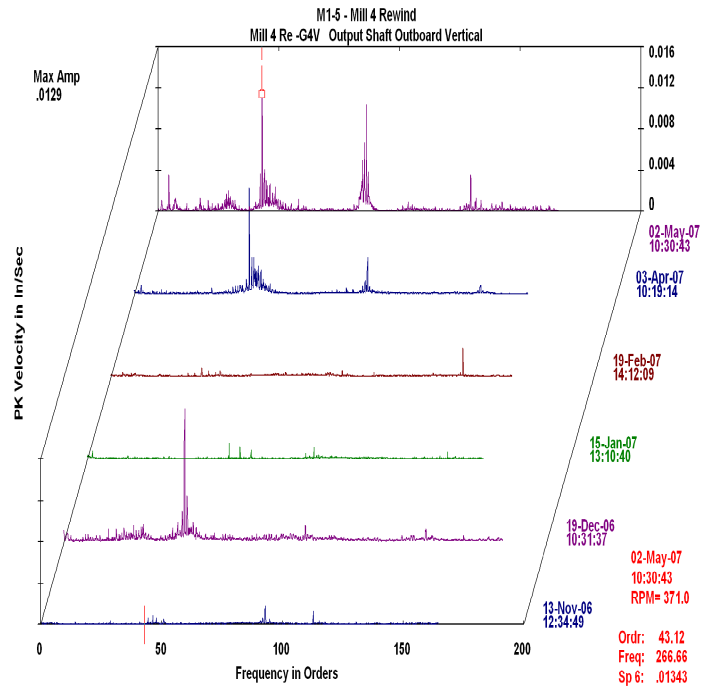
Area M1-5 Mills 1, 2, 3, 4 & 5
Equipment Mill 4 Re Mill 4 Rewind

Most gearbox points have 280- Hz vibration with sidebanding. Amplitudes are higher than last month. No fault frequencies match. Suspect this is a gear defect.

Recommend taking an oil sample on the gearbox.

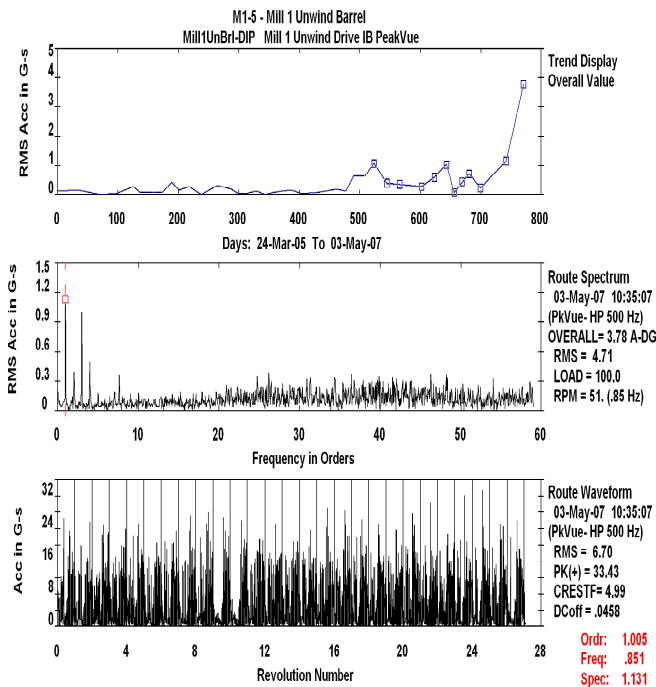
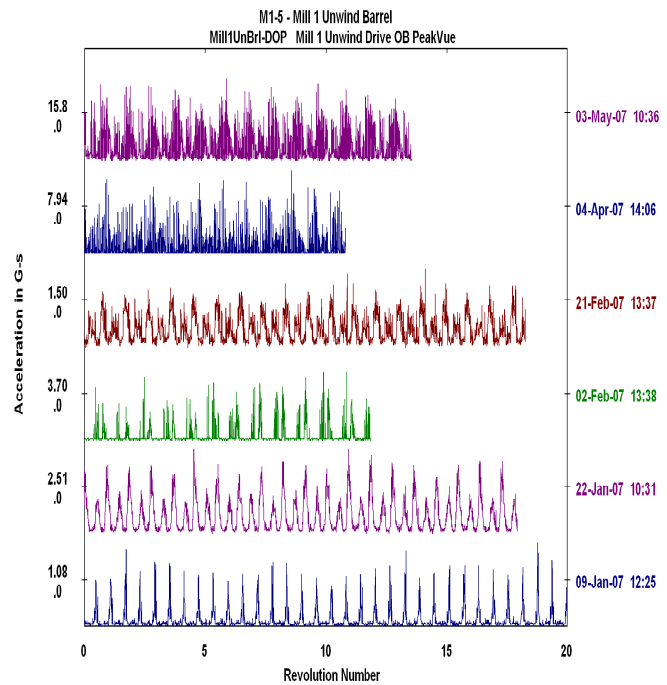
Area M1-5 Mills 1, 2, 3, 4 & 5
Equipment Mill1UnBri Mill 1 Unwind Barrel

The unwind drive inboard and outboard PeakVue points have increasing impacting. The waveform is periodic and repeating.

Recommend inspecting the bearings for proper lubrication and defects.

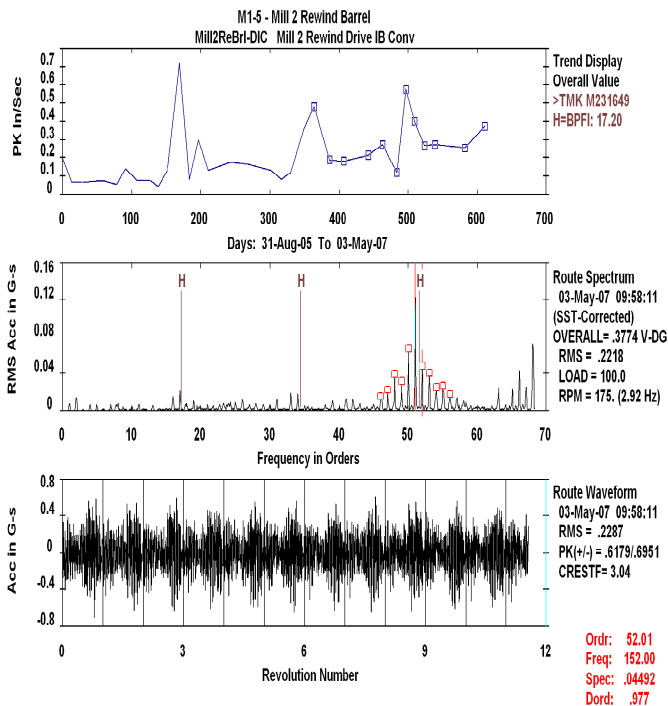
Area M1-5 Mills 1, 2, 3, 4 & 5
Equipment Mill2ReBrI Mill 2 Rewind Barrel

The rewind drive inboard point has harmonics of inner race defect with sidebands. This indicates an inner race bearing defect.

Recommend inspecting the rewind drive inboard bearing for defects.

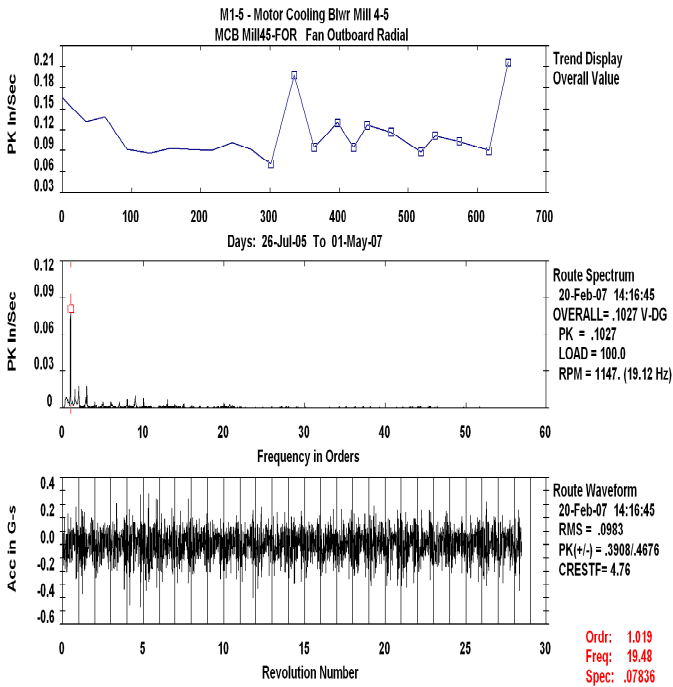
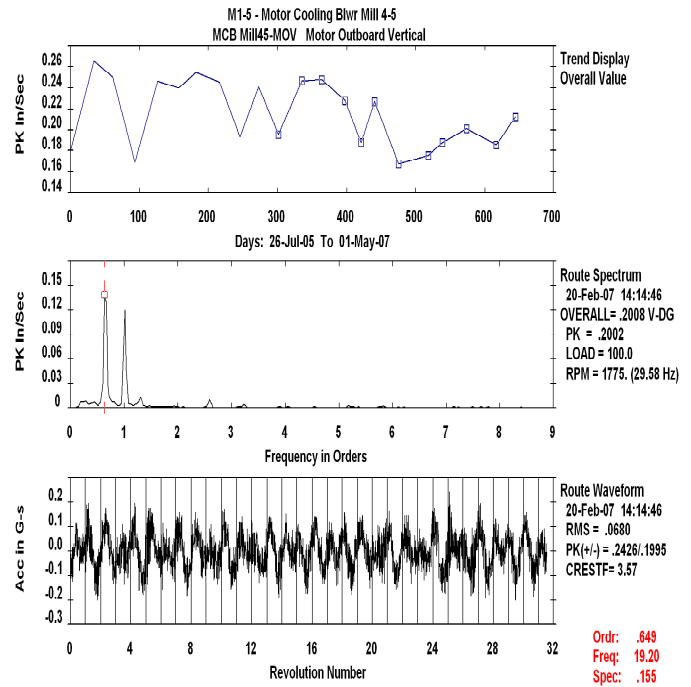
Area M1-5 Mills 1, 2, 3, 4 & 5
Equipment MCB Mill45 Motor Cooling Blwr Mill 4-5

Explanation: The fan points have increasing 1x fan speed vibration and the motor points have increasing 1x fan and 1x motor speed vibration. There is little impacting in the waveform.

No maintenance is recommended at this time. Continue to monitor next month.

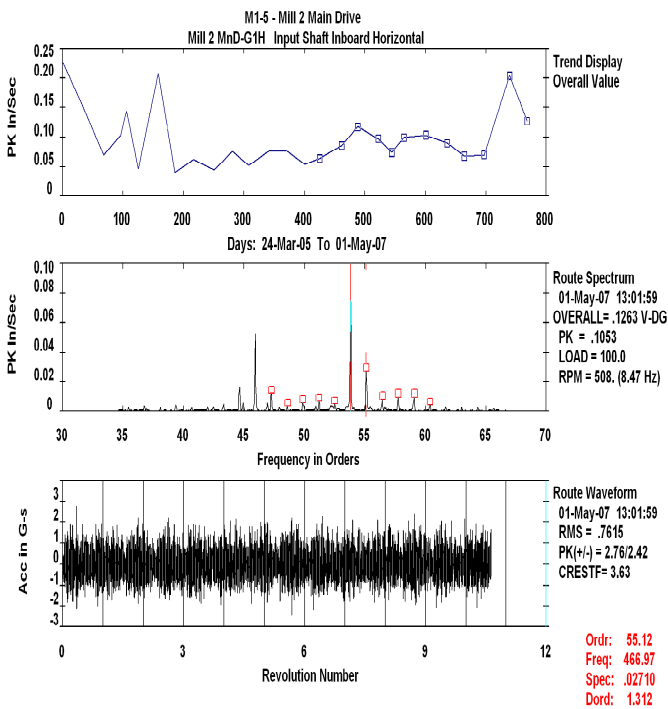
Area M1-5 Mills 1, 2, 3, 4 & 5
Equipment Mill 2 MnD Mill 2 Main Drive

Explanation: The gear defect seen on the G1H point last month has decreased significantly but is still visible. Impacting has decreased but is still higher than before.

No maintenance is recommended at this time. Continue to monitor.

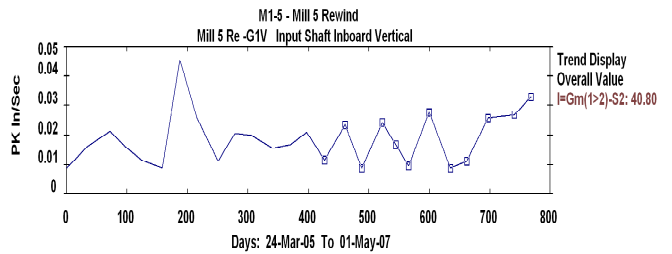
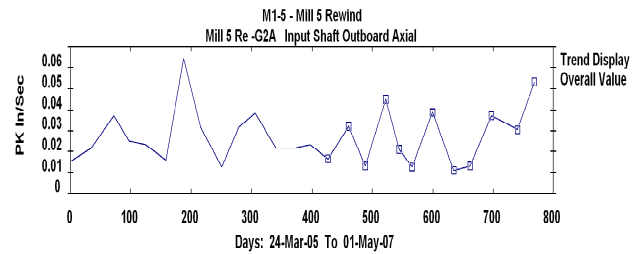
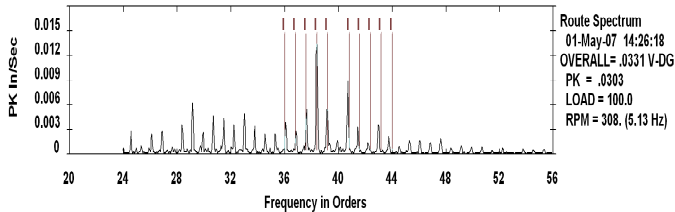
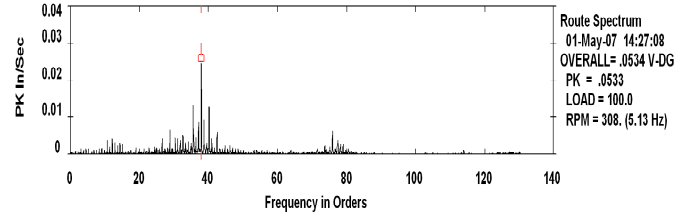
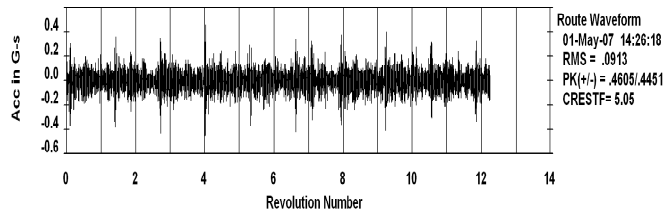
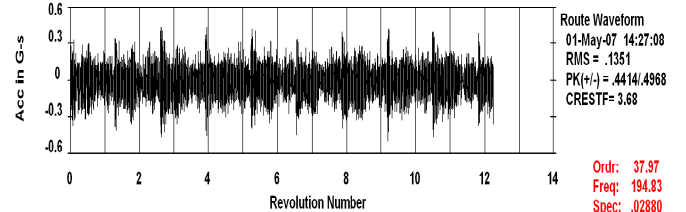
Area M1-5 Mills 1, 2, 3, 4 & 5
Equipment Mill 5 Re Mill 5 Rewind

Explanation: The input shaft has gearmesh with sidebands indicating a possible gear defect.
 No maintenance is recommended at this time. Continue to monitor next month.

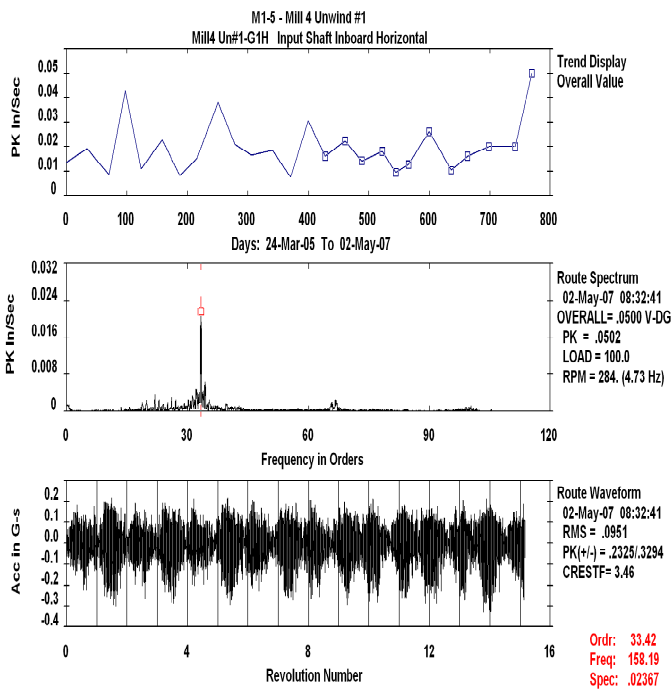
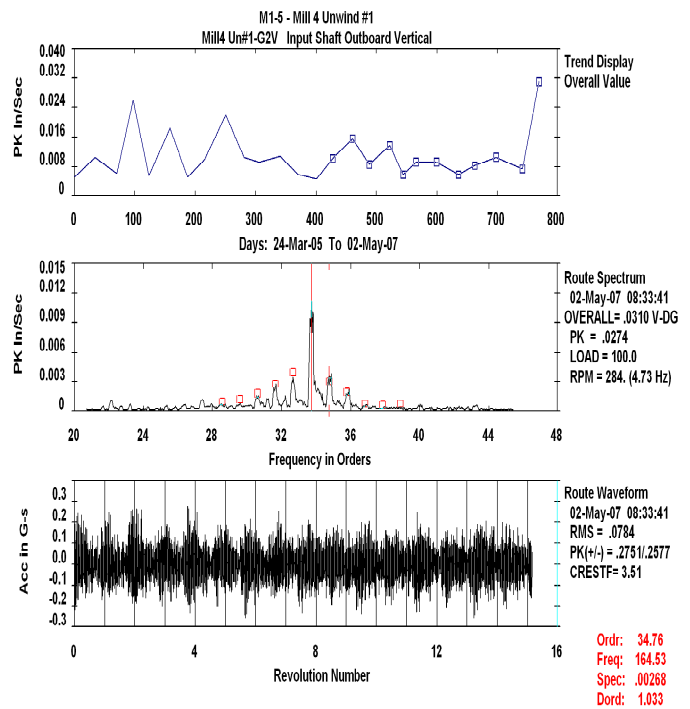
Area M1-5 Mills 1, 2, 3, 4 & 5
Equipment Mill4 Un#1 Mill 4 Unwind #1

Explanation: The gearbox points have a 158 Hz vibration peak with sidebanding. This indicates a possible gear defect. This frequency does not match any defined gears.

No maintenance is recommended at this time. Continue to monitor next month.

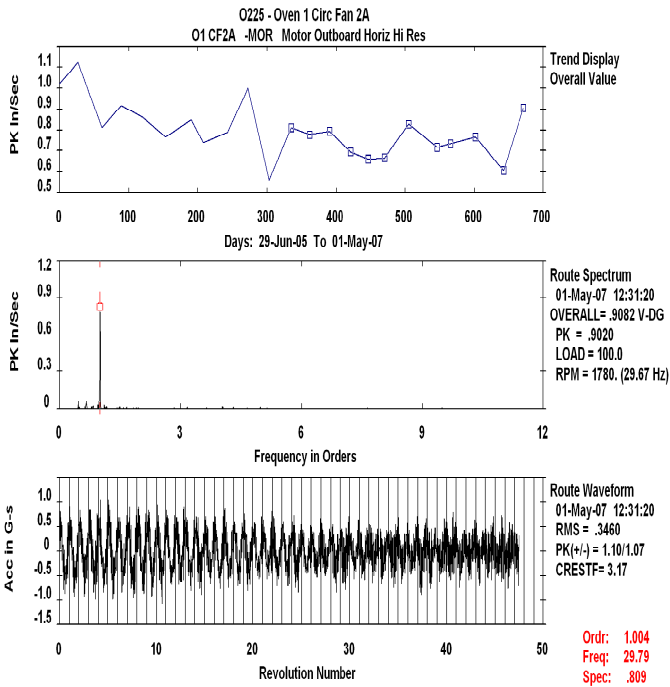
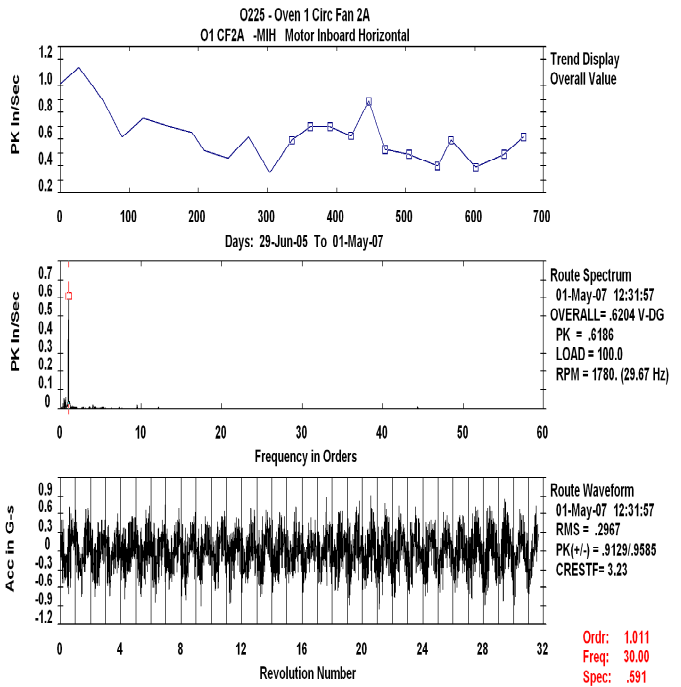
Area O225 Oven 1, 22, 24 & 25
Equipment O1 CF2A Oven 1 Circ Fan 2A

The 1x turn speed vibration on the motor outboard horizontal point is increasing. This indicates imbalance or a mounting hardware issue.

Recommend inspecting motor for imbalance and mounting hardware for security.

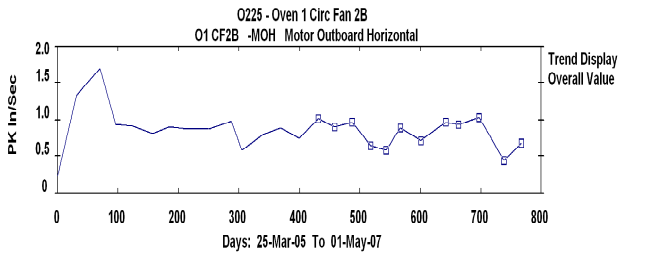
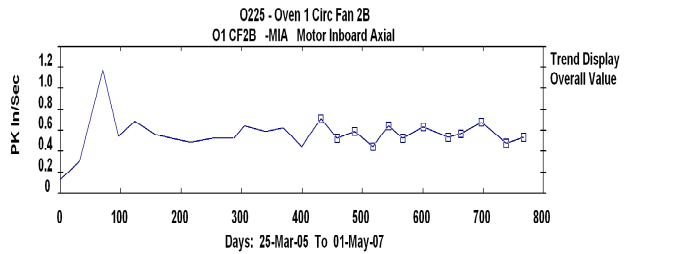
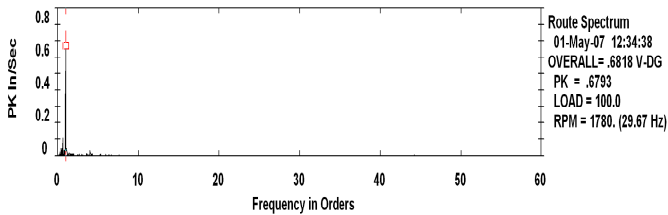
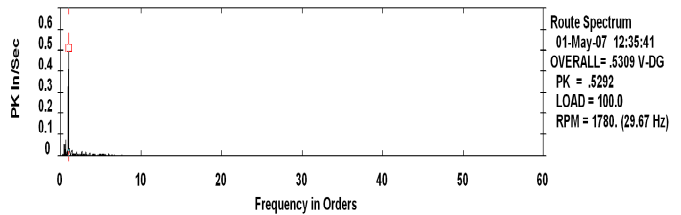
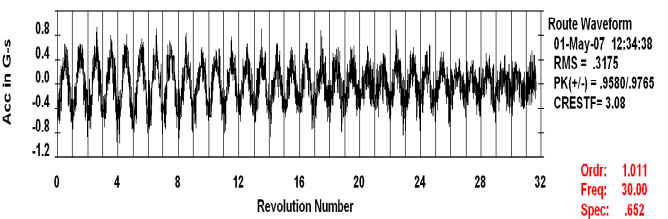
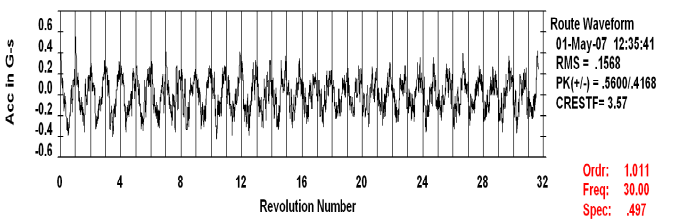
Area O225 **Oven 1, 22, 24 & 25**
Equipment O1 CF2B Oven 1 Circ Fan 2B

The motor horizontal and axial points show a high 1x turn speed vibration. This may be due to imbalance in the motor or misalignment or loose mounting hardware.

Recommend inspecting the motor for imbalance, proper mounting hardware security, and coupling misalignment.

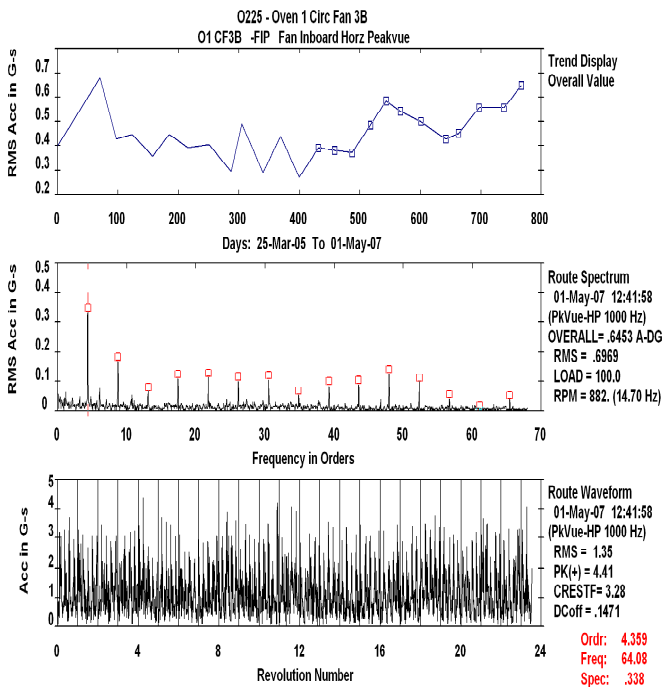
Area O225 Oven 1, 22, 24 & 25
Equipment O1 CF3B Oven 1 Circ Fan 3B

The fan PeakVue point continues to have 4.35x fan speed harmonics. This indicates a possible bearing fault. Levels are about higher than last month.

Recommend inspecting the fan bearing for proper lubrication and defects.

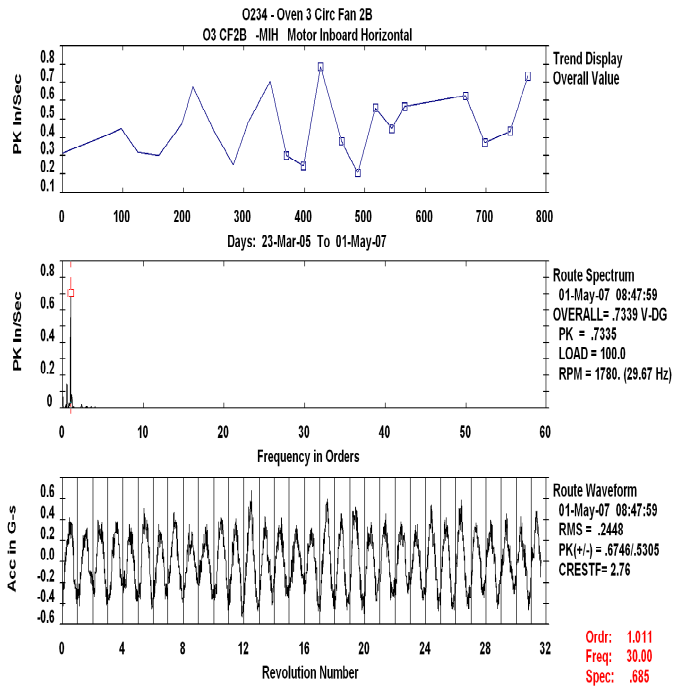
Area O234 Ovens 2, 3, 4 & 15
Equipment O3 CF2B Oven 3 Circ Fan 2B

Explanation: The motor inboard horizontal point has an increasing 1x turn speed vibration indicating imbalance in the motor.

Recommend inspecting the motor mounting hardware for security and other defects.

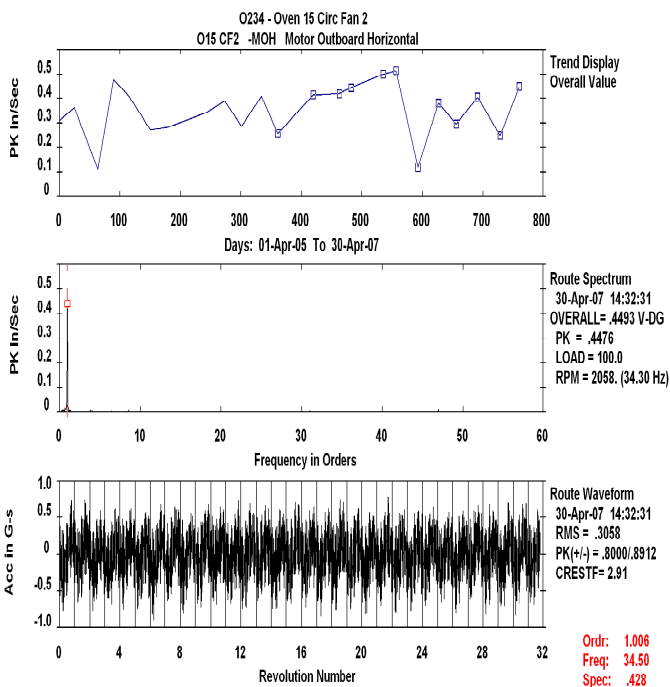
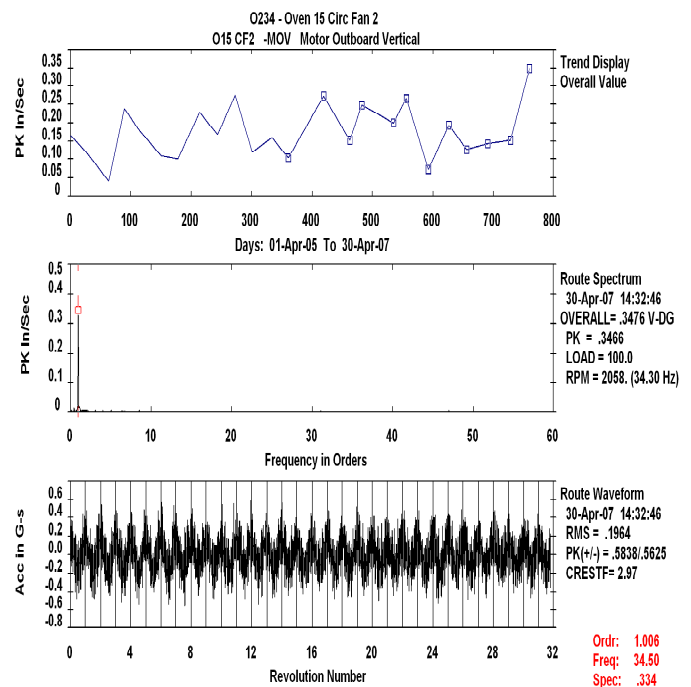
Area **O234** **Ovens 2, 3, 4 & 15**

Explanation: The motor points have an increasing 1x turn speed vibration indicating imbalance in the motor.

No maintenance recommended at this time. Continue to monitor next month.

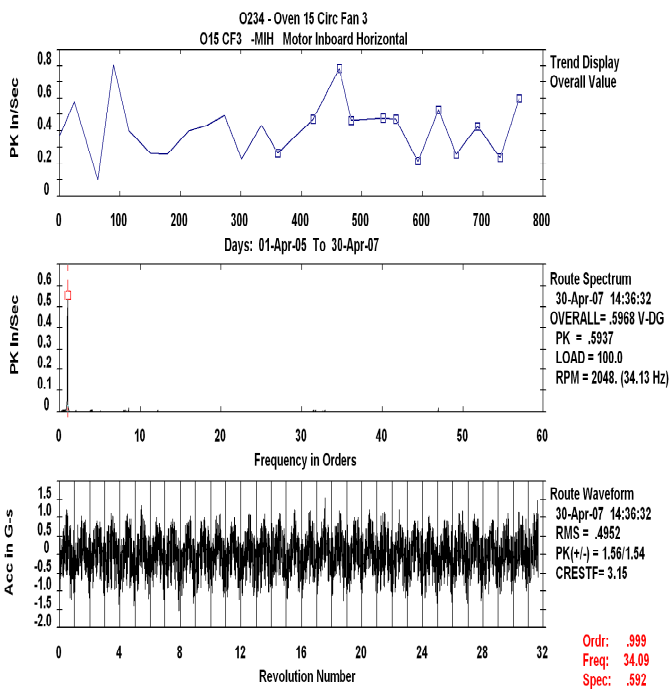
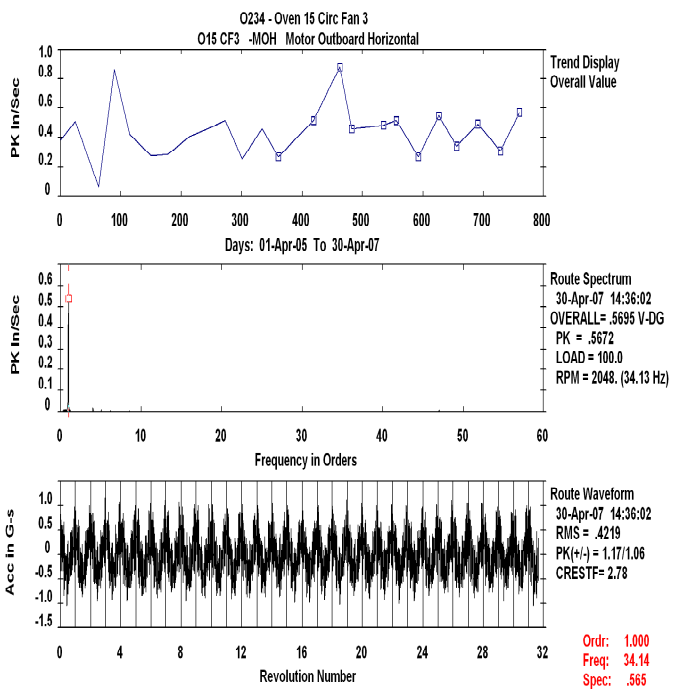
Area O234 Ovens 2, 3, 4 & 15
Equipment O15 CF3 Oven 15 Circ Fan 3

Explanation: The motor points have an increasing 1x turn speed vibration indicating imbalance in the motor.
 No maintenance recommended at this time. Continue to monitor next month.
