ELIMINATING TROUBLESOME TUBING

Mike Sommerlot, Emerson Automation Solutions, says valve actuator instrument tubing can be subject to abuse, and damage from vibration and environmental extremes, which is why the company's 667 size i actuators now eliminate this problematic element

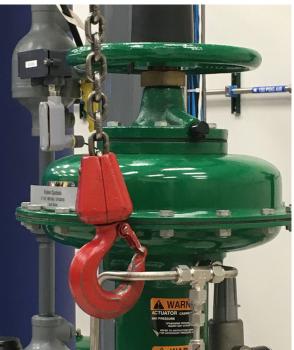
Figure 1: External instrument tubing on a control valve can be easily damaged by improper use – such as picking up the valve by the tubing line

Valve actuator instrument tubing (Figure 1) can have a tough life. It can be damaged by rough handling during shipping or transport. Workers tend to lean ladders against it, stand on it, pick up valves by grabbing onto the tubing, overtighten connections and hang onto it for support.
