CFE MEDIA'S
OIL & GAS[®]
ENGINEERING

March 2021

Next-gen trim cuts rotary valve cavitation

Enabled by additive manufacturing; proved in river water trial

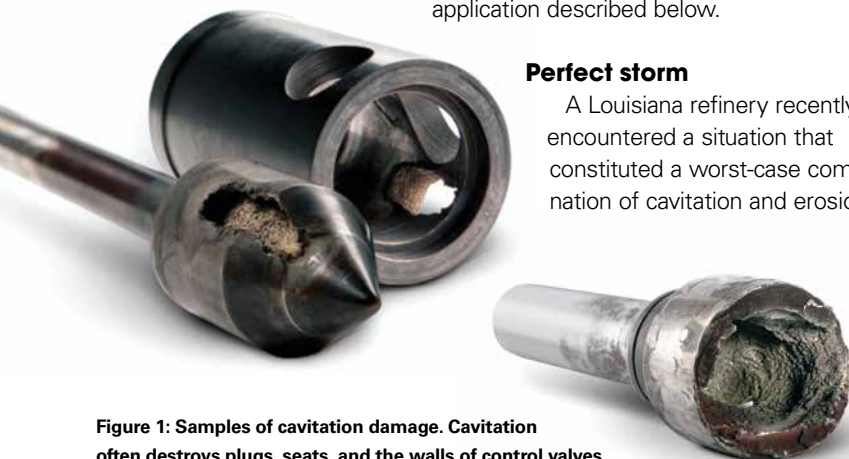
Figure 1: Samples of cavitation damage. Cavitation often destroys plugs, seats, and the walls of control valves and downstream piping. Image courtesy Emerson

As the fluid passes beyond the trim and velocity slows, the pressure returns and the vapor bubbles collapse. The implosion of the bubbles creates localized micro jets and shockwaves that can severely damage valve components and piping, especially if the bubble happens to be near a metal surface (Figure 1).

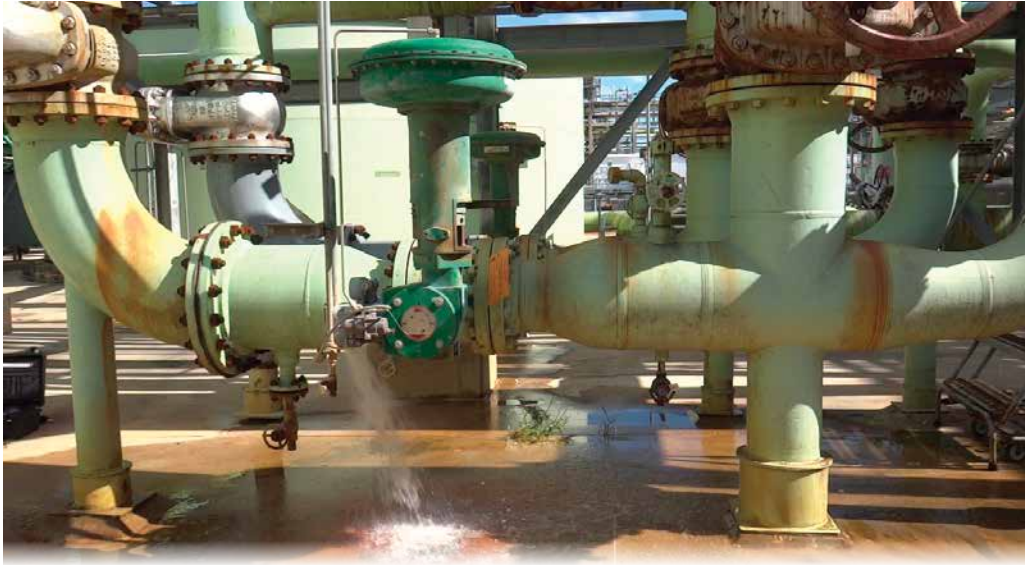
Figure 2: Downstream piping fails due to extreme cavitation and the erosive effects of river silt striking the pipe wall. Note the river water spraying out of the pipe at the bottom left of the photo. Image courtesy Emerson

In addition, the high-velocity river silt had an erosive effect that exacerbated the equipment damage. The cavitating liquid exiting the 10" rotary globe valve was impinging on the wall of the downstream piping. The combination of cavitation and river silt erosion began wearing through the pipe wall and eventually breached it (Figure 2).

Due to pressure boundary loss from cavitation and erosion damage, the control valve was replaced every 24 months, and the downstream piping was replaced every six to twelve months. A surprise breach leading to unexpected downtime is costly. Providing a safer situation for plant personnel was a high priority for the refinery.

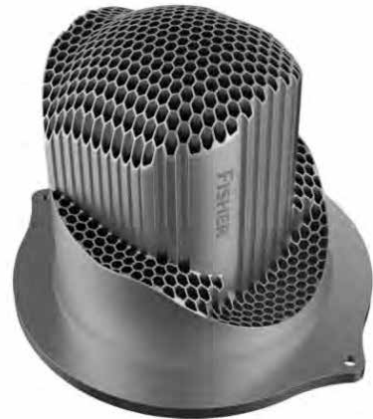
Figure 4: Anti-cavitation trim embodies a design enabled by additive manufacturing. The trim can be retrofitted to existing valves and works well at any throttling position. Flow enters the above diagram from the left. Image courtesy Emerson

would have been impossible or prohibitively expensive to fabricate just a few years ago. The required parts are created from a variety of high-grade, high-strength alloys. One of these new designs is the Cavitrol Hex anti-cavitation trim offered for the Fisher Vee-ball rotary control valve (Figure 4).

Unlike previous designs, this rotary valve anti-cavitation trim is inserted into the valve from the downstream side and is not connected to the rotating ball in any way, allowing the trim to perform as desired to reduce cavitation regardless of the degree of valve opening. It also can be retrofitted and installed into any existing Fisher Vee-ball valve.

The specialized flow channels reduce cavitation within the valve and direct the process fluid straight downstream. Since liquid flow no longer impinges on the pipe walls, downstream pipe damage is reduced, while the trim protects the valve from cavitation damage.

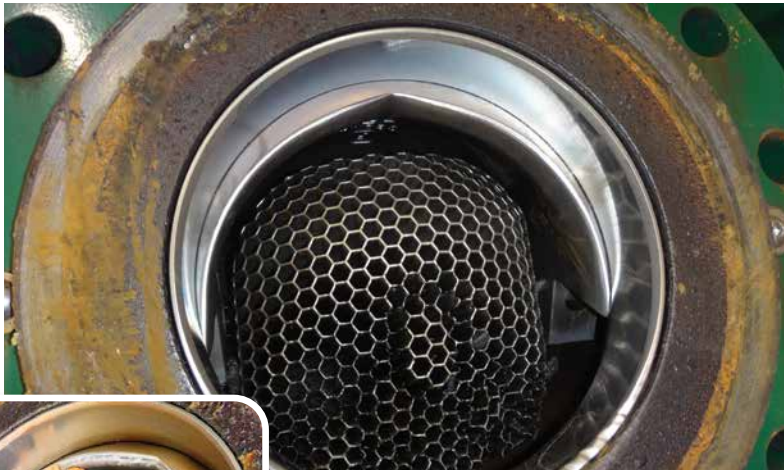
Figure 5: After a year in service there was no sign of downstream piping damage and damage was limited to relatively minor erosion on the face of the trim. The valve body suffered no damage at all. Image courtesy Emerson

At the previously mentioned Louisiana refinery, an existing 10" rotary valve in river water service was replaced with a 10" Fisher 300# Vee-Ball valve with a Cavitrol Hex anti-cavitation trim. Cavitation noise and vibration abatement were immediately apparent. After a year in service, the valve was pulled and inspected (Figure 5).

No damage to the downstream piping was apparent. Damage to the valve was limited to erosion of the lower section of the anti-cavitation trim face. The refinery staff was pleased with the result since damage to the pressure retaining components appeared to be

stopped, noise and vibration was significantly reduced and erosion effects from entrained particulate in the process fluid was limited to the replaceable Cavitrol Hex trim only.

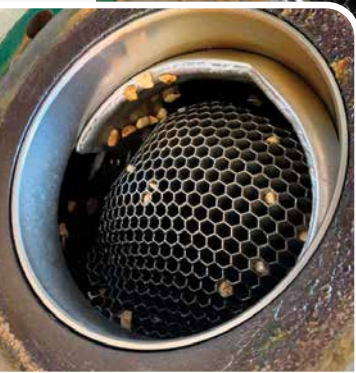
Figure 6: The anti-cavitation trim was replaced with a higher hardness R31233 alloy and returned to service for another year. The inspection team found a few small rocks stuck in the trim, but no damage to downstream piping, no damage to the valve body and reduced erosion damage of the Hex trim. Image courtesy Emerson

After inspecting the valve, Emerson and Impact Partner John H. Carter Co. offered an upgraded trim composed of R31233 alloy rather than the original S31603 material. This higher hardness cobalt alloy was better suited to handle the erosive nature of the river silt. New trim was installed, and the valve returned to service. After another year of punishing conditions, the valve was again pulled for inspection.

Other than finding some small rocks trapped in the trim that had slipped through an upstream filter, the inspection team found no damage to the downstream piping and valve body, and significantly reduced erosion damage to the Cavitrol Hex trim (Figure 6).
