## JUICE MANUFACTURER IMPROVES MEASUREMENT AND RELIABILITY OF CIP FEED WITH MAGMETER TECHNOLOGY

CIP cleaning fluid feed to blending plant

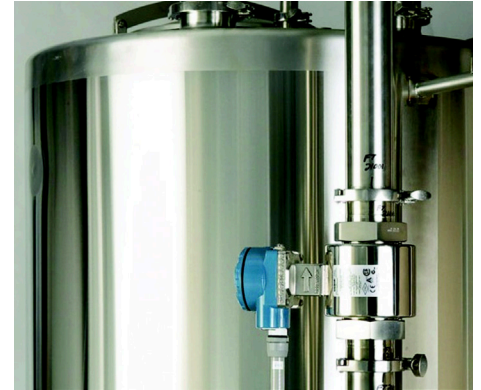
*Rosemount 8721 Hygienic Magmeter installation*

This manufacturer selected the Rosemount 8721 Hygienic Magmeter for this difficult application. The customer was already using the 8721 for flow measurement in other parts of the manufacturing process with great success. The wide variety of electrode options allowed the user to select a material that would withstand the corrosive properties of the Clean-In-Place (CIP) fluid, extending the life of the flow meter.

The durability of the Rosemount 8721 Hygienic Magmeter reduced process downtime caused by corrosion due to the CIP fluid.
