## MULTIPHASE METERS DETECTING FRACK WATER CROSS-CONTAMINATION IN THE PERMIAN BASIN IN NORTH AMERICA

An operator in the Permian Basin in North America

Unconventional oil well production

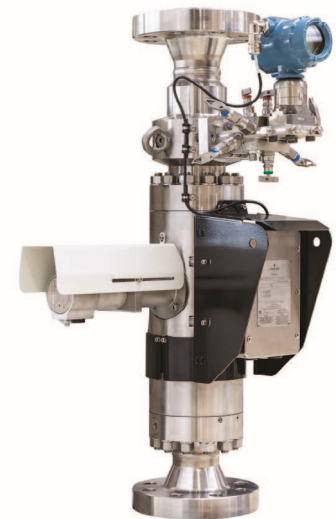
*Image 1. The Roxar 2600 Multiphase Flow Meter*

An operator in the Permian basin had two Roxar™ 2600 Multiphase Flow Meters (MPFM) installed, performing rotational well testing of 9 individual well streams. The operator was also taking advantage of Roxar 2600 MPFM Performance Monitoring. This is a service in which data is made accessible, and Emerson experts perform data analysis, diagnostics on meter health, and identify unusual changes of flowing conditions, in order to support the operator with actionable data insights.

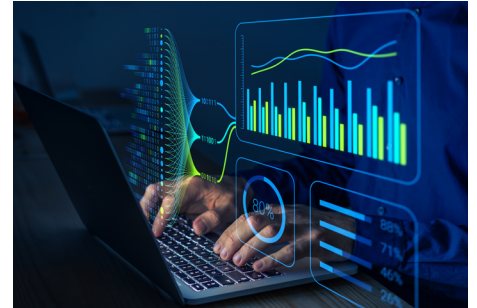
*Image 2. Harnessing the power of Emerson expertise with Roxar 2600 MPFM Performance Monitoring*
