CHIYODA SAVED \$1M IN A MEGA LNG PROJECT WITH THE ROSEMOUNT CONDITIONING ORIFICE PLATE

Chiyoda Corporation Designing four LNG trains as an EPC Contractor for a large gas company in the Middle East

To measure the discharge flow rate of 3150 kW pumps (three pumps in each LNG Train, 12 pumps in total)

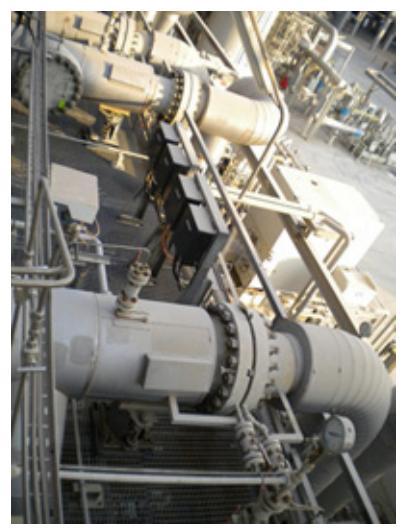
Rosemount Conditioning Orifice Plate installed

Chiyoda chose to install Rosemount[™] 1595 Conditioning Orifice Plates with a 0.65 Beta as they only required two pipe diameters from the flow disturbance. This enabled them to install the flow meter in the location that was specified in the original design with no engineering changes needed. The use of two pipe diameters saved Chiyoda plant space as well as saving crucial engineering man-hours, since a redesign of the flow meter installation was not needed. Chiyoda saved \$1M USD in total on the 12 installations.

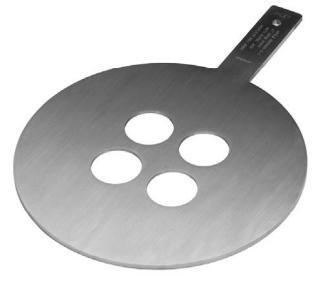
Rosemount 1595 Conditioning Orifice Plate
