Protecting Magnetic Flow Meters in Vacuum Situations

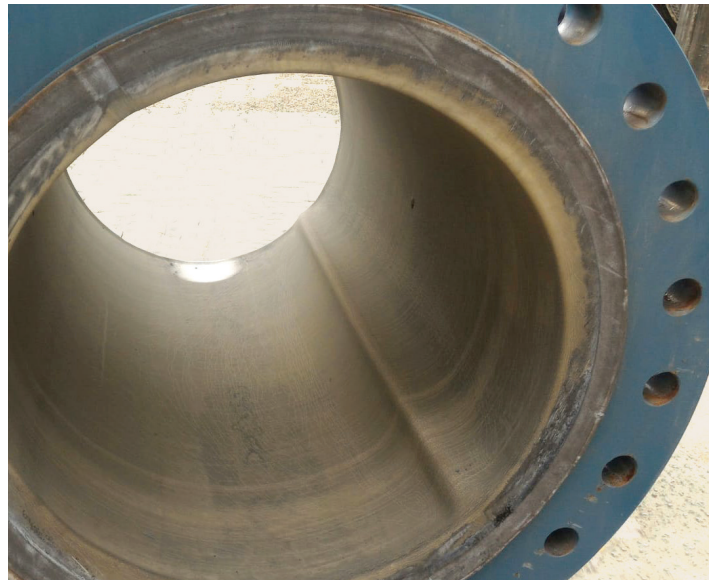
Vacuum damage has a very distinct and easily identifiable appearance. In all cases the liner will form a linear “lobe” (often times more than one) which protrudes into the tube’s bore and typically runs the length of the tube. In applications where the tube is mounted horizontally, as the liquid level drops, the lobe will form in the void space that is created at the highest point, regardless of the meter’s orientation in the process piping. Generally, in horizontal applications the lobe will not form where the weight of the liquid is still resting on and supporting the liner.

In vertical applications it is not uncommon to see a collapse pattern that has a “tri-lobe” appearance with three almost equally spaced lobes protruding into the bore of the tube. This pattern occurs when the tube empties completely and evenly from one end to the other subjecting the entire liner through the bore of the meter to the vacuum. In either orientation, the vacuum can become so deep that the electrode heads will pull through the liner if a lobe develops through one or both of the electrode plains.

For applications where vacuum pressure is being intentionally introduced and for applications where a vacuum pressure may be unexpectedly introduced as described above, it is recommended that a vacuum break be installed directly upstream of the meter as a means of protecting the magnetic flowmeter from damage due to the creation of the vacuum.
