Hydrocarbon Processing Terminal Saves \$80K USD Yearly in Servicing with a 4-Stage Fisher™ Dirty Service Trim

Raw crude wellhead feed

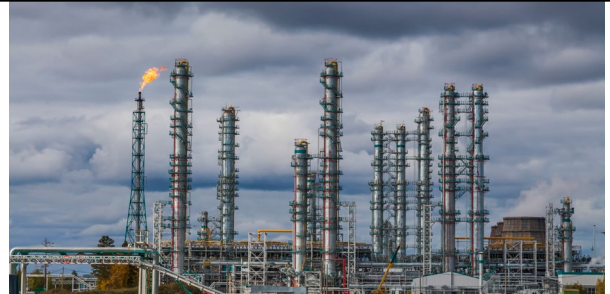
The Fisher Dirty Service Trim (DST) offered a multi-stage control valve solution that prevented cavitation due to high-pressure drops, and long-term reliability which eliminated quarterly maintenance downtime in the terminal.

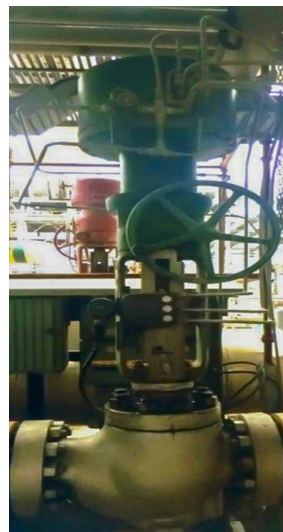
Figure 1. Original valve utilized an HP Cavitrol III 3-stage trim facing clogging issues

The 3-stage 6 in HPT Cavitrol™ III valves that supplied the terminal required servicing every three months due to changing conditions leading to cavitation, cage clogging, and erosion damage. The trim is removed, unclogged, replaced for soft parts, and reattached into the circulation. During this time, the plant ran on standby pumps.

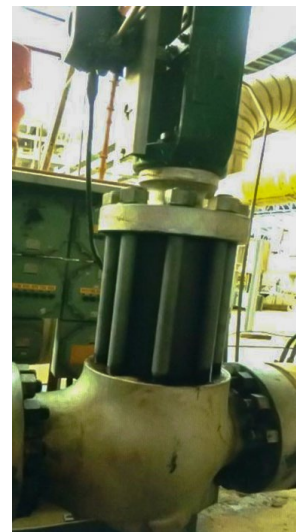
Figure 2. Retrofitted Fisher DST utilized a 4-stage trim

After a thorough review and an informed valve selection process, the plant switched to a 4-stage Fisher Dirty Service Trim (DST). Its anti-cavitation design can handle high-pressure drop applications of up to 4200 psid, eliminating the associated damage, vibration, and noise causing quarterly downtimes. On the same note, the retrofit design ensured proper sizing and customized pressure drop staging.
